# New Hampshire Volunteer Lake Assessment Program

## 2003 Biennial Report for Pleasant Lake Deerfield

NHDES Water Division Watershed Management Bureau 29 Hazen Drive Concord, NH 03301

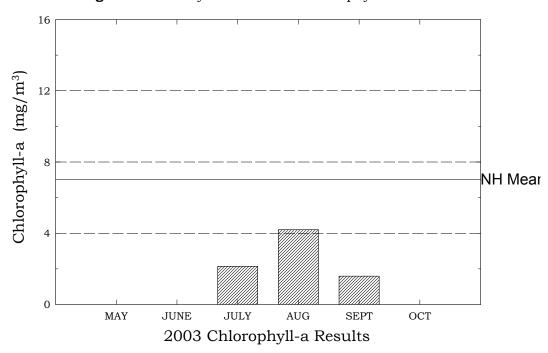
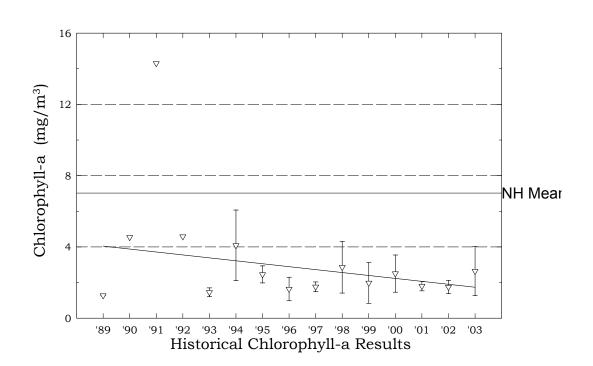
Figure 1. Monthly and Historical Chlorophyll-a Results

The current year data (the top graph) show that the chlorophyll-a concentration *increased* from July to August, and then *decreased* from August to September. The chlorophyll-a concentration in all three months was *less than* the state mean.

The historical data (the bottom graph) show that the 2003 chlorophyll-a mean is *less than* the state mean.

Overall, the statistical analysis of the historical data (the bottom graph) shows that the mean annual chlorophyll-a concentration has **not significantly changed** (either *increased* or *decreased*) since monitoring began in **1989**. Specifically, the chlorophyll-a concentration has remained **relatively stable** and with the exception of 1991 has been **less than** the state median. (Note: Please refer to Appendix E for the detailed statistical analysis explanation and data print out.)

Figure 1 and Table 1: The graphs in Figure 1 (Appendix A) show the historical and current year chlorophyll-a concentration in the water column. Table 1 (Appendix B) lists the maximum, minimum, and mean concentration for each sampling season that the lake/pond has been monitored through the program.

While algae are naturally present in all lakes/ponds, an excessive or increasing amount of any type is not welcomed. In freshwater lakes/ponds, phosphorus is the nutrient that algae depend upon for growth. Algal concentrations may increase with an increase in nonpoint sources of phosphorus loading from the watershed, or inlake sources of phosphorus loading (such as phosphorus releases from the sediments). Therefore, it is extremely important for volunteer monitors to continually educate residents about how activities within the watershed can affect phosphorus loading and lake/pond quality.

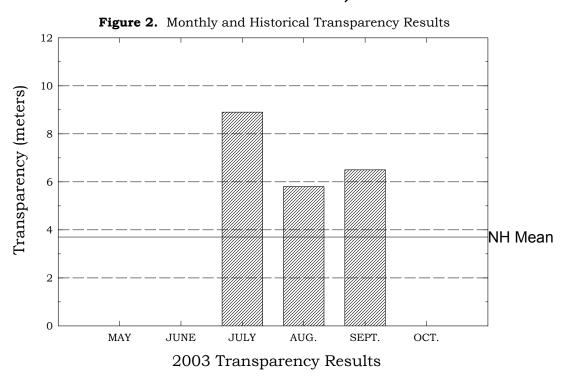
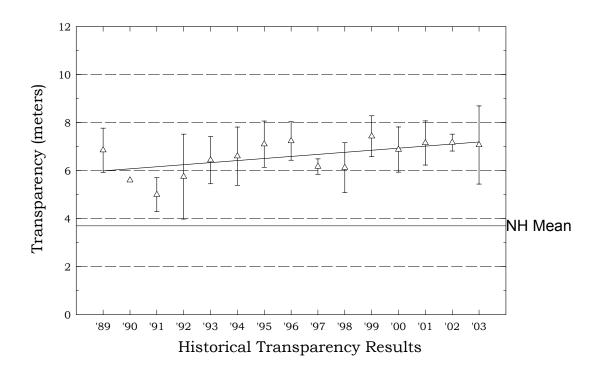
The current year data (the top graph) show that the in-lake transparency **decreased** from July to August, and then **slightly increased** from August to September. The transparency in all three months was **greater than** the state mean.

The historical data (the bottom graph) show that the 2003 mean transparency is *greater than* the state mean.

Overall, the statistical analysis of the historical data show that the mean annual in-lake transparency has **significantly increased** since monitoring began. Specifically, the transparency has **increased** (meaning **improved**) on average by **approximately 1.4 percent** per sampling season during the sampling period **1989** to **2003**. (Note: Please refer to Appendix E for the statistical analysis explanation and data print out.) We hope this trend continues!

Figure 2 and Table 3: The graphs in Figure 2 (Appendix A) show historical and current year data for lake/pond transparency. Table 3 (Appendix B) lists the maximum, minimum and mean transparency data for each sampling season that the lake/pond has been monitored through the program.

Typically, high intensity rainfall causes erosion of sediments into lakes/ponds and streams, thus decreasing clarity. Efforts should continually be made to stabilize stream banks, lake/pond shorelines, disturbed soils within the watershed, and especially dirt roads located immediately adjacent to the edge of tributaries and the lake/pond. Guides to Best Management Practices designed to reduce, and possibly even eliminate, nonpoint source pollutants, such as sediment loading, are available from DES upon request.

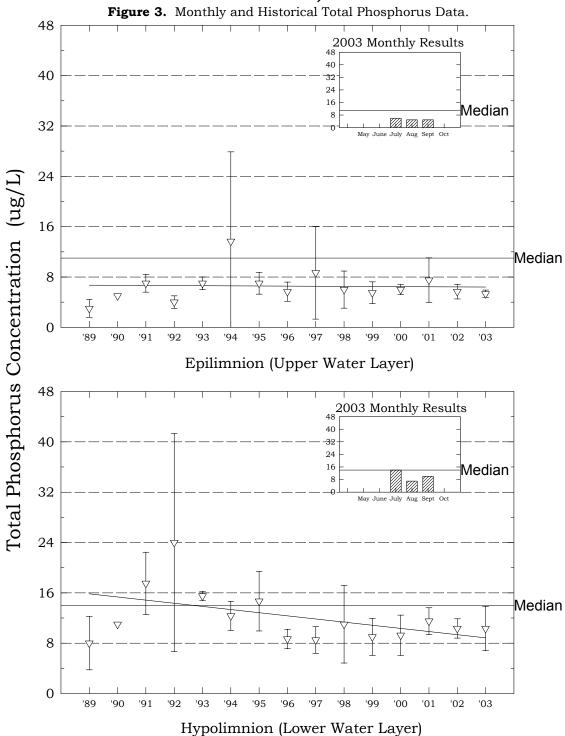
The current year data for the epilimnion (the top inset graph) show that the phosphorus concentration **remained stable** from July to September. The phosphorus concentration in all three months was **less than** the state median.

The historical data show that the 2003 mean epilimnetic phosphorus concentration is *less than* the state median.

The current year data for the hypolimnion (the bottom inset graph) show that the phosphorus concentration *decreased* from July to August, and then *increased* from August to September. The phosphorus concentration in July was *approximately equal to* the state median while August and September concentrations were less than the state median.

The historical data show that the 2003 mean hypolimnetic phosphorus concentration is *less than* the state median.

Overall, the statistical analysis of the historical data show that the phosphorus concentration in the epilimnion (upper layer) and the hypolimnion (lower layer) has **not significantly changed** (either increased or decreased) since monitoring began in **1989**. Specifically, the phosphorus concentration in the epilimnion has remained **relatively stable** and has been **less than** the state median. The phosphorus concentration in the hypolimnion has remained **relatively stable** and **approximately equal to** the state median. (Note: Please refer to Appendix E for the statistical analysis explanation and data print out.)

Figure 3 and Table 8: The graphs in Figure 3 (Appendix A) show the amounts of phosphorus in the epilimnion (the upper layer) and the hypolimnion (the lower layer); the inset graphs show current year data. Table 8 (Appendix B) lists the annual maximum, minimum, and median concentration for each deep spot layer and each tributary since the lake/pond has joined the program.

One of the most important approaches to reducing phosphorus loading to a waterbody is to continually educate watershed residents about its sources and how excessive amounts can adversely impact the ecology and value of lakes and ponds. Phosphorus sources within a lake or pond's watershed typically include septic systems, animal waste, lawn fertilizer, road and construction erosion, and natural wetlands.
